### **TECHNICAL REPORT ARCCB-TR-99013**

# THERMAL DAMAGE AND SHEAR FAILURE OF CHROMIUM PLATED COATING ON AN A723 STEEL CANNON TUBE

# JOHN H. UNDERWOOD ANTHONY P. PARKER

**JULY 1999**

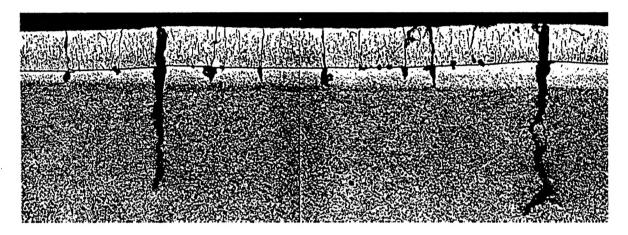
Figures 1 and 2 summarize some key features of the thermal damage that occurs in the near-bore region of a modern tank cannon. Each of the photomicrographs shows a typically 0.15-mm thick electroplated chromium layer near the top of the photo, and the 1100 MPa yield strength A723 steel below. Figure 1 shows thermal effects in both coating and steel of cannon A, notably a subtle 1322°K chromium recrystallization to a depth about two-thirds through the coating, and a quite clear 1022°K steel transformation to a depth about 0.07-mm below the interface. The use of these effects as accurate local temperature measurements to verify the thermomechanical modeling has been described in References 3 and 4. Another feature clearly shown in Figure 1, and one that will have importance later, is the wide variation in crack widths

in the chromium coating. Note that the cracks that extend deep into the steel have great width, whereas the cracks that extend only through or part through the transformed layer of steel have much less width. This and other features were carefully measured in dozens of photomicrographs such as that of Figure 1.

Figure 1. Polished and etched section from near-bore region of cannon A at 1.5-m forward of breech end of tube; longitudinal orientation (100X).

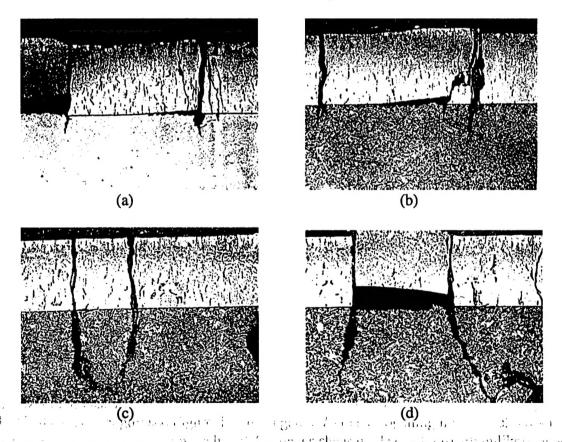
Figure 2. Polished and etched section from near-bore region of cannon B (130X). Figures 2(a) and (b) are longitudinal orientation at 1.5-m forward of breech end of tube. Figures 2(c) and (d) are transverse orientation at 0.7-m forward of breech end of tube.

Examples of progressive damage in cannon B are shown in Figure 2. The samples shown were etched to reveal the chromium recrystallization, and all but sample (a) were also etched to reveal the steel microstructure. As expected, considering the lower gas temperature of cannon B, the extent of chromium recrystallization (shown as a light etching region) was much less than that for cannon A. And also, as expected, there was more recrystallization closer to the hotter breech end of the cannon, (c) and (d), than farther from the breech, (a) and (b). Finally, there is no indication in Figure 2 of steel transformation, which again, is consistent with the lower gas temperature of cannon B.

Damage processes that lead to the critical separation of a chromium segment are shown in Figure 2, and are interpreted as follows: Figures 2(a) and (b) each show a segment about half separated, accompanied by concentrated cracking damage, and uplifting of the chromium at the separated end of the segment. Each of these features suggests that a substantial contact has occurred between the separated end of the segment and the neighboring segment. The upcoming analysis will explore thermal stresses that could account for both the segment contact and separation. Figure 2(c) shows an example of a potential segment separation caused by undermining of a segment of chromium by two cracks that join. Figure 2(d) shows a segment that has separated and in the process of final departure. Note in each of the cases of partial or complete separation—(a), (b), and (d)—an open region is present adjacent to the segment to facilitate separation. In (a) there is an already separated segment (to the left), and in (b) and (d) there are widely open cracks. The presence of an open region adjacent to a separating segment is generally noted and appears to be required to facilitate separation.

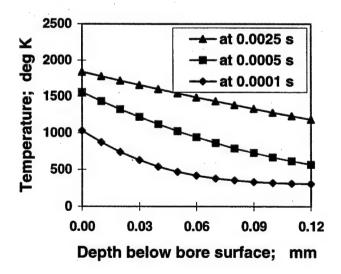
Temperature distributions for various times, following initial application of hot gases to the bore surface of the chromium coating, are shown in Figure 5, for a location 1.5-m forward of the breech end of cannon A. For these and all other results shown, the following thermal properties and other parameters were used in equations (10) and (11), as appropriate:

Figure 5. Temperature distribution in chromium coating of cannon A at 1.5-m forward of breech, for various times after round passage.

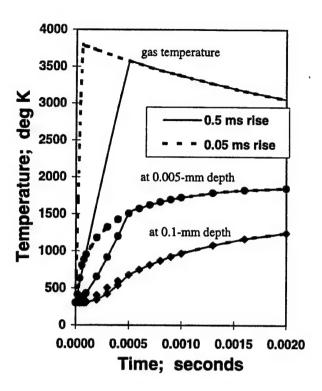
The last question for discussion here related to thermal shear failure of chromium segments is the effect of the time rate of thermal stress application on failure. The round velocity and the resulting rate of application of hot gases to the bore surface of the chromium vary by several multiples of ten during the first meter of travel. This variation in velocity leads to variation in the temperature rise time of the gases at the bore surface. For example, if the distance over which the temperature rises from  $T_i$  to  $T_{gas}$  is 0.001-m and the round velocity is 200 m/s, then the temperature rise time would be 0.05 ms. This rise time and one ten times longer. corresponding to a lower-round velocity, are considered in the following analysis of segment shear stress. Figure 9 shows effects of the two different temperature rise times on the temperature distributions calculated from equation (10), and Figure 10 shows the resulting segment shear stresses using equations (11) (with  $T_c = 0$ ) and (12). Both temperature and shear stress are considerably reduced, but only within the time period corresponding to the rise time. Note that dT/dt and  $d\tau_{APP}/dt$  are much lower for the slower rise time. This lesser amount of thermal shock associated with the lower round velocity could account for the observed lesser amount of chromium loss at 0.7-m forward of the breech compared with 1.5-m forward, discussed earlier. The high values of segment shear stress that occur later in time are not affected by temperature rise time, and thus cannot account for the observed differences in chromium loss.

Figure 9. Effect of temperature rise time due to round passage on chromium temperature at various times and depths for cannon A.
